Insurer Directed Poor Quality Unsafe Repair

2007 Subaru Impreza

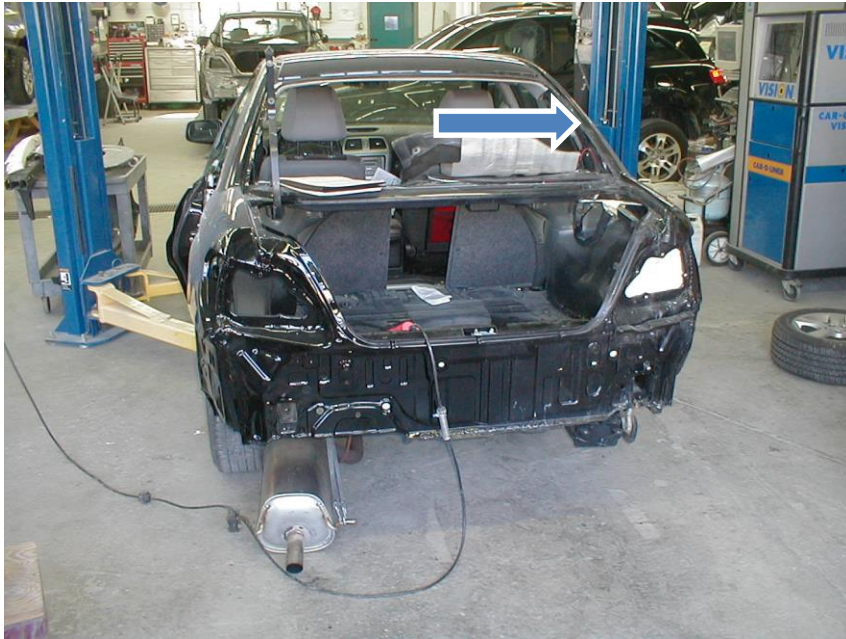
**Arrow points to area of
poor repair on vehicle**

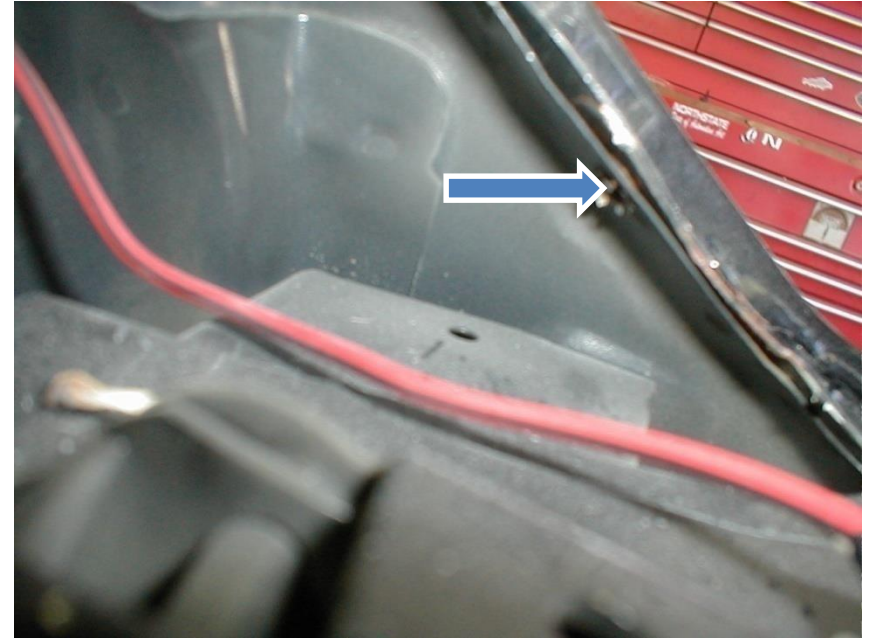
**Poor quality, and insufficient
number of welds causing
panel separation and rust
condition**

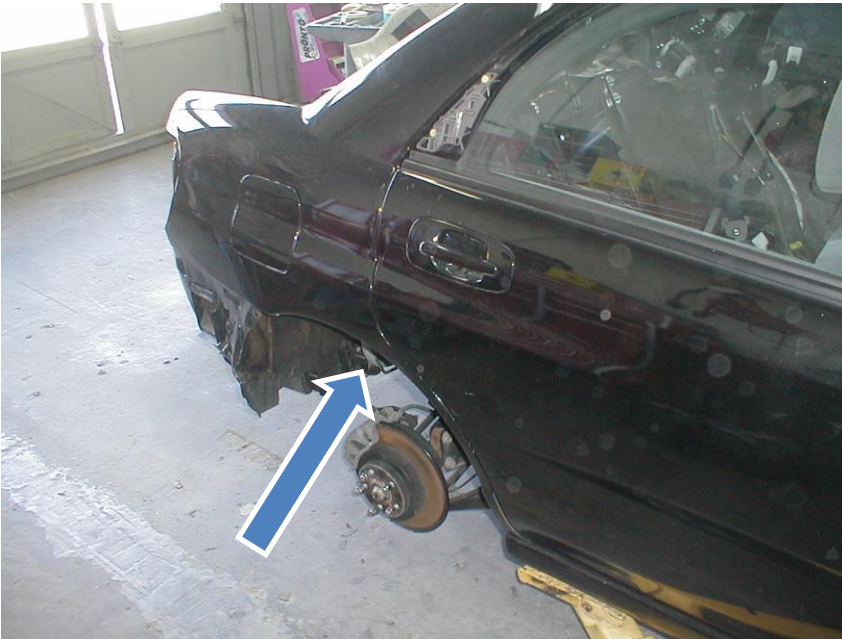
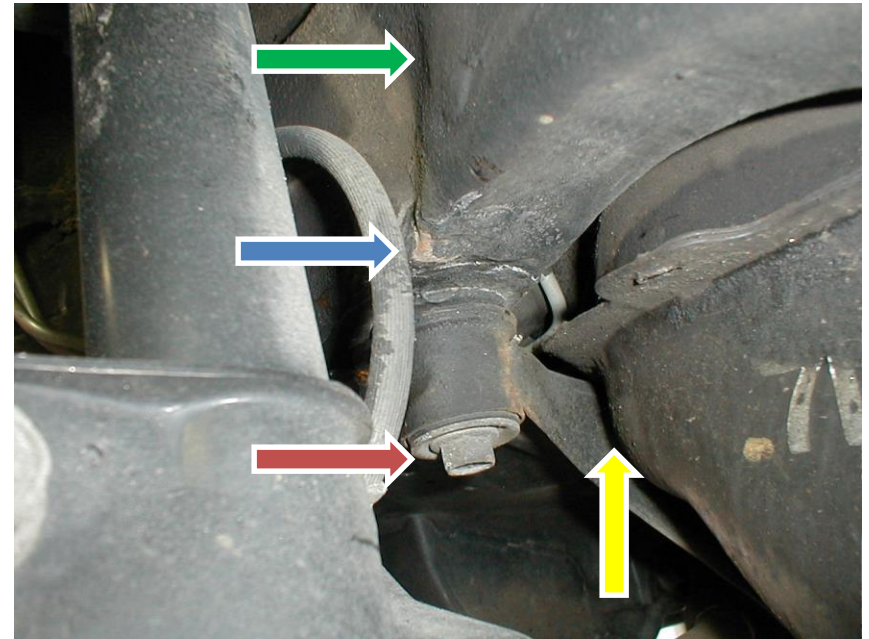
Arrow points to area where frame rail and suspension carrier are located

Because of the weakened and brittle condition of the frame rail, if vehicle sustained another rear-end impact, the possibility of the suspension carrier being driven into the fuel tank causing catastrophic results is very high.

1. Green arrow points to severe buckle in repaired frame rail.

2. Blue arrow points to improperly heated area of frame rail causing high strength steel to become brittle and rusty.

3. Red arrow points to main rear suspension carrier bolt.

4. Yellow arrow points to minimal gap between fuel tank on right side and suspension carrier on left side of arrow.

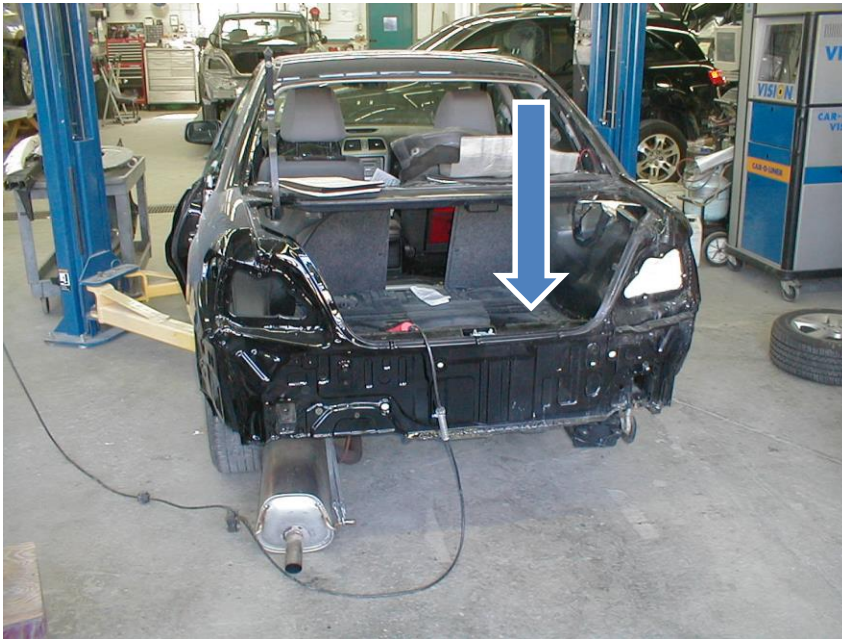
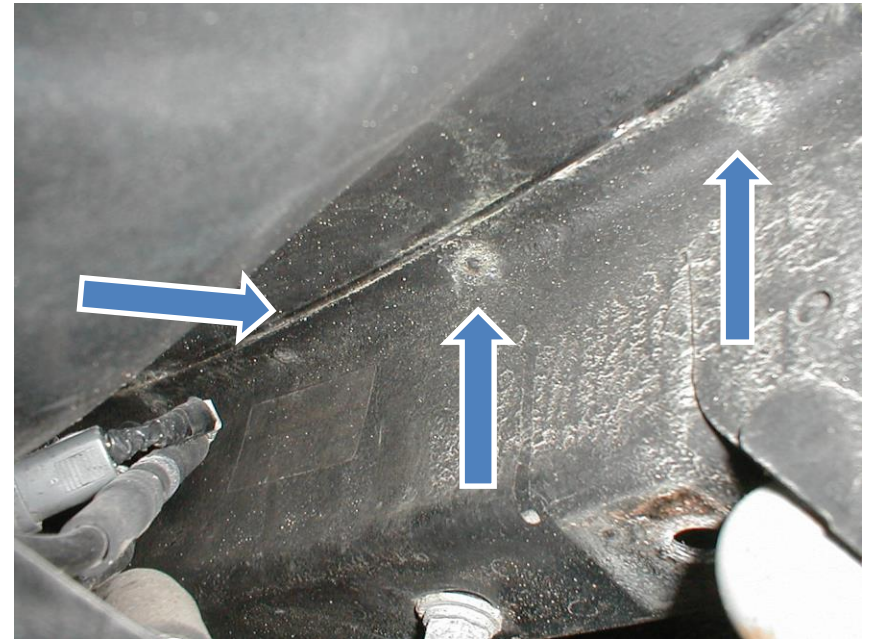
Arrow points to top side of trunk floor where frame rail is welded to underside

Poor quality and insufficient welds from trunk floor to right rear frame rail panels not aligned or mated properly. No seam sealer or corrosion protection

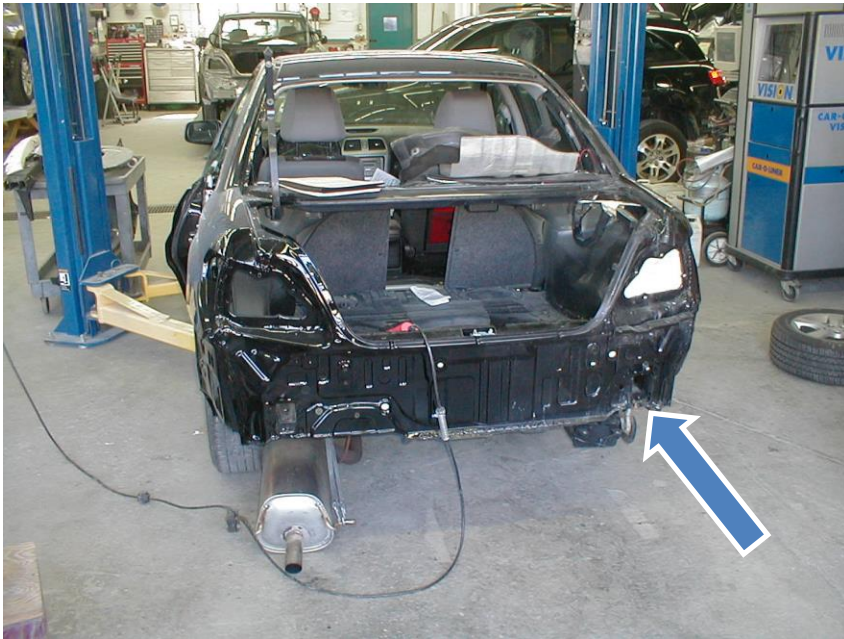
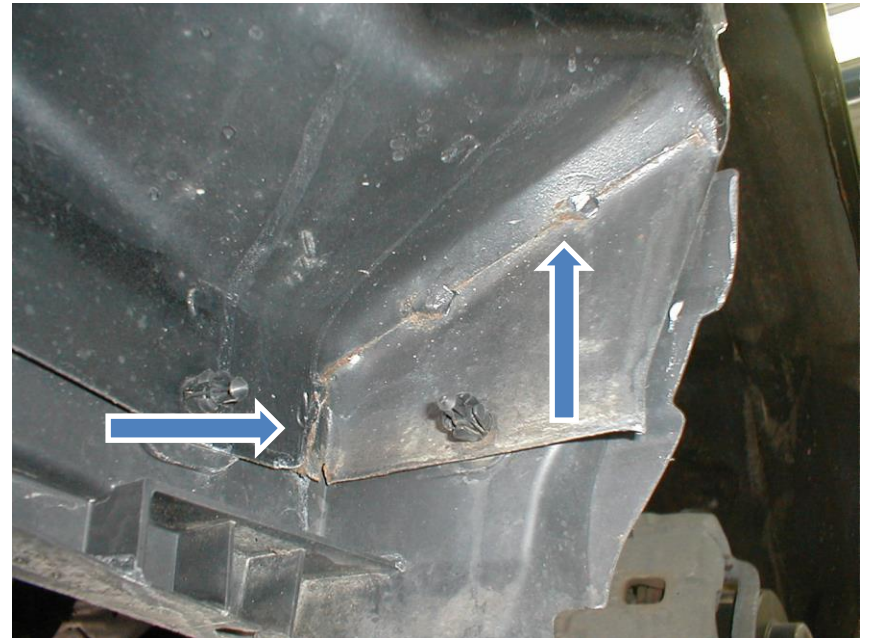
Arrow points to area of quarter panel extension

Right rear quarter panel to floor extension. Metal fatigued and torn with poor quality welds. No seam sealer, paint or corrosion protection.

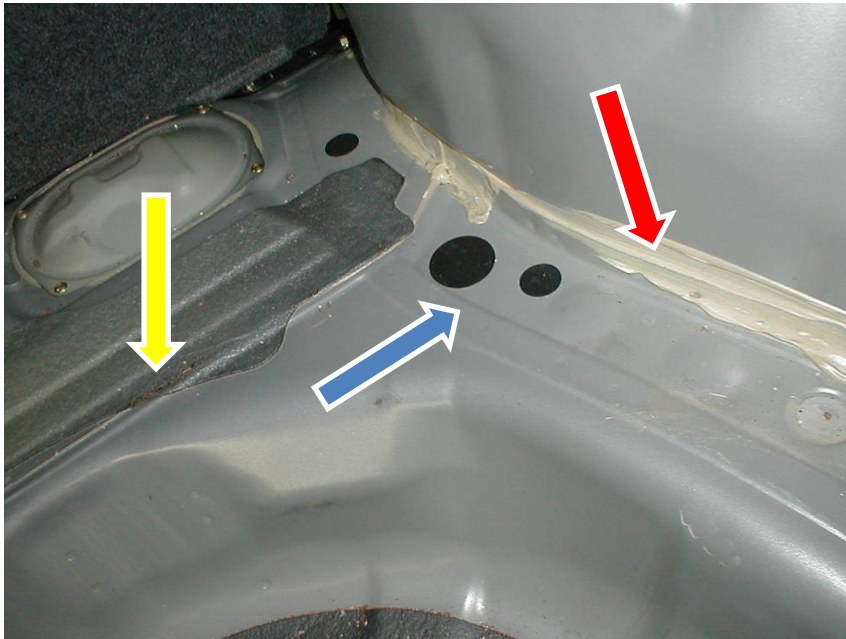
**Exact undamaged vehicle trunk floor.
Arrows correspond to poorly repaired
photo on right. Repairer should have
duplicated look and function to bring
vehicle as close to pre-loss condition as
possible.**

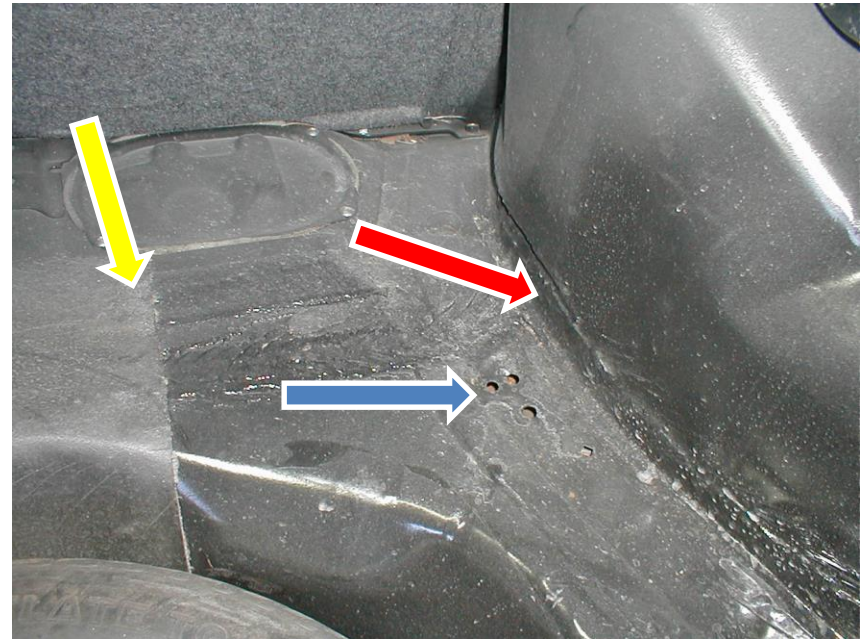
**Red arrow points to insufficient and improper
application of seam sealer.**

**Blue arrow points to unplugged holes in frame
rail causing exhaust fumes and moisture into
trunk and passenger compartment.**

**Yellow arrow points to improper sound
deadening material and improper location.**

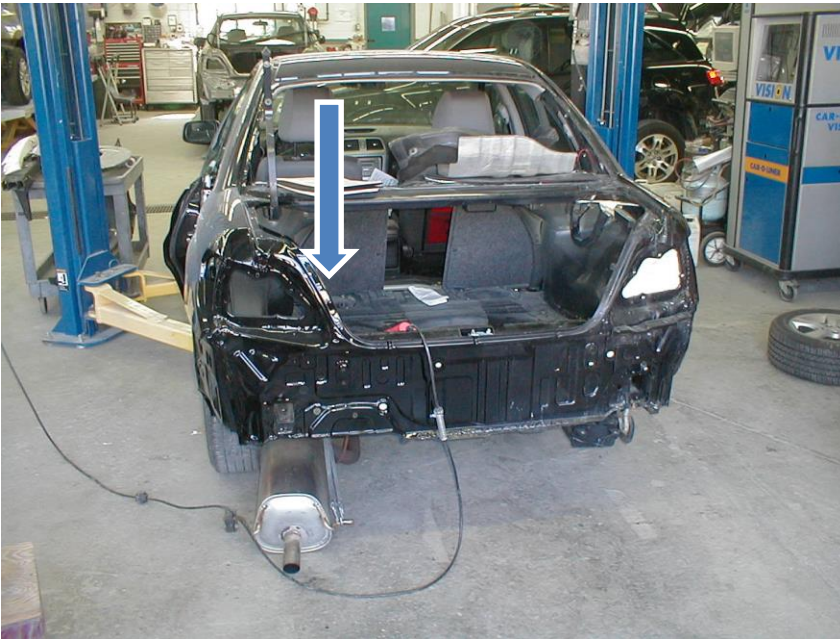
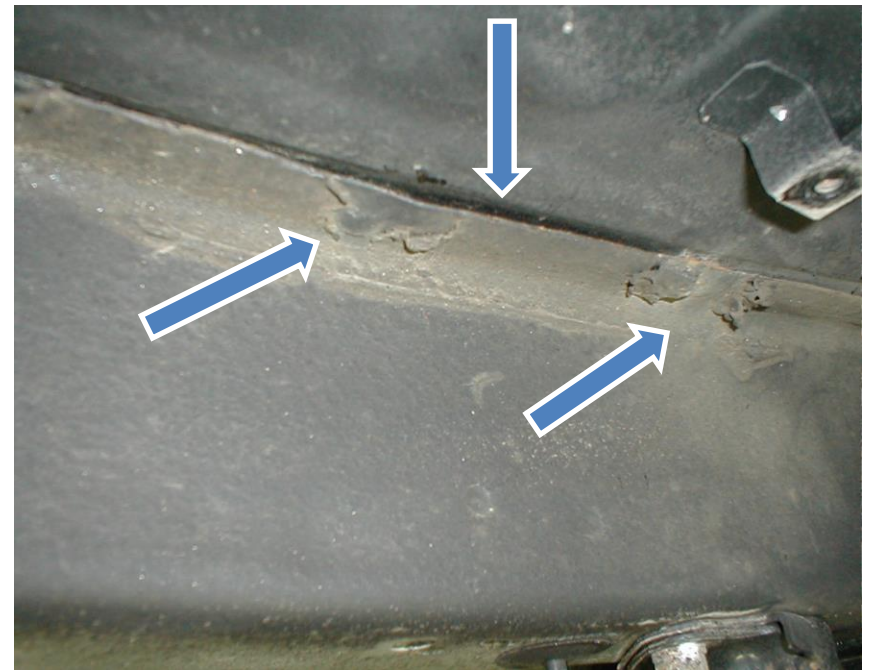
Arrow points to top-side of trunk floor where frame rail is welded to underside

Poor quality and insufficient welds from trunk floor to left rear frame rail, panels not aligned or mated properly. No seam sealer or corrosion protection

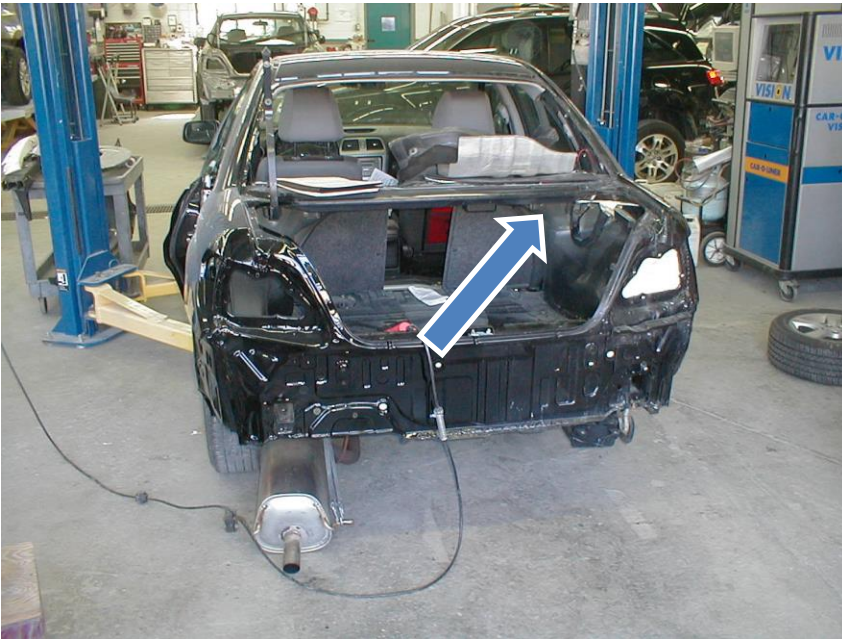
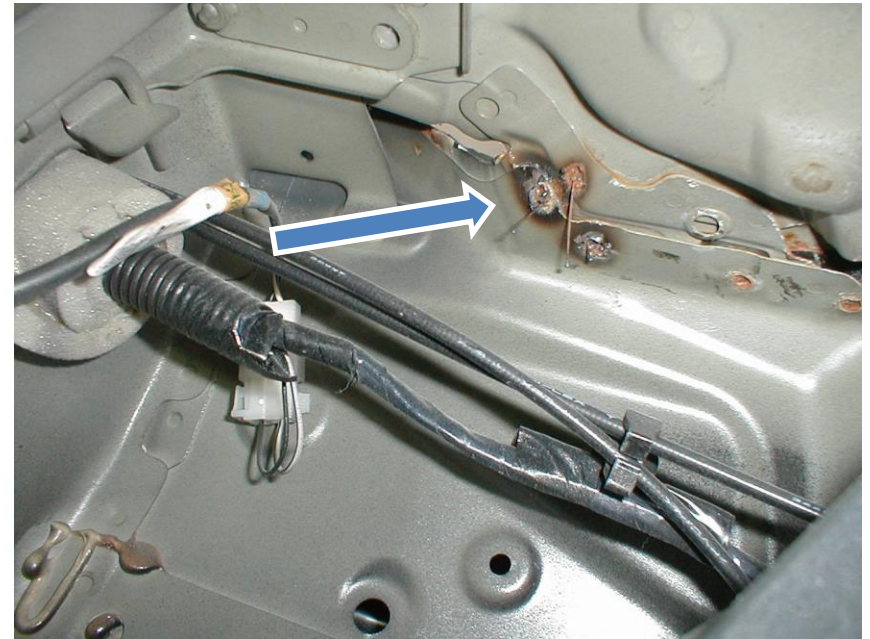
Arrow points to area of poor welds

Poor welds, no paint, no corrosion protection

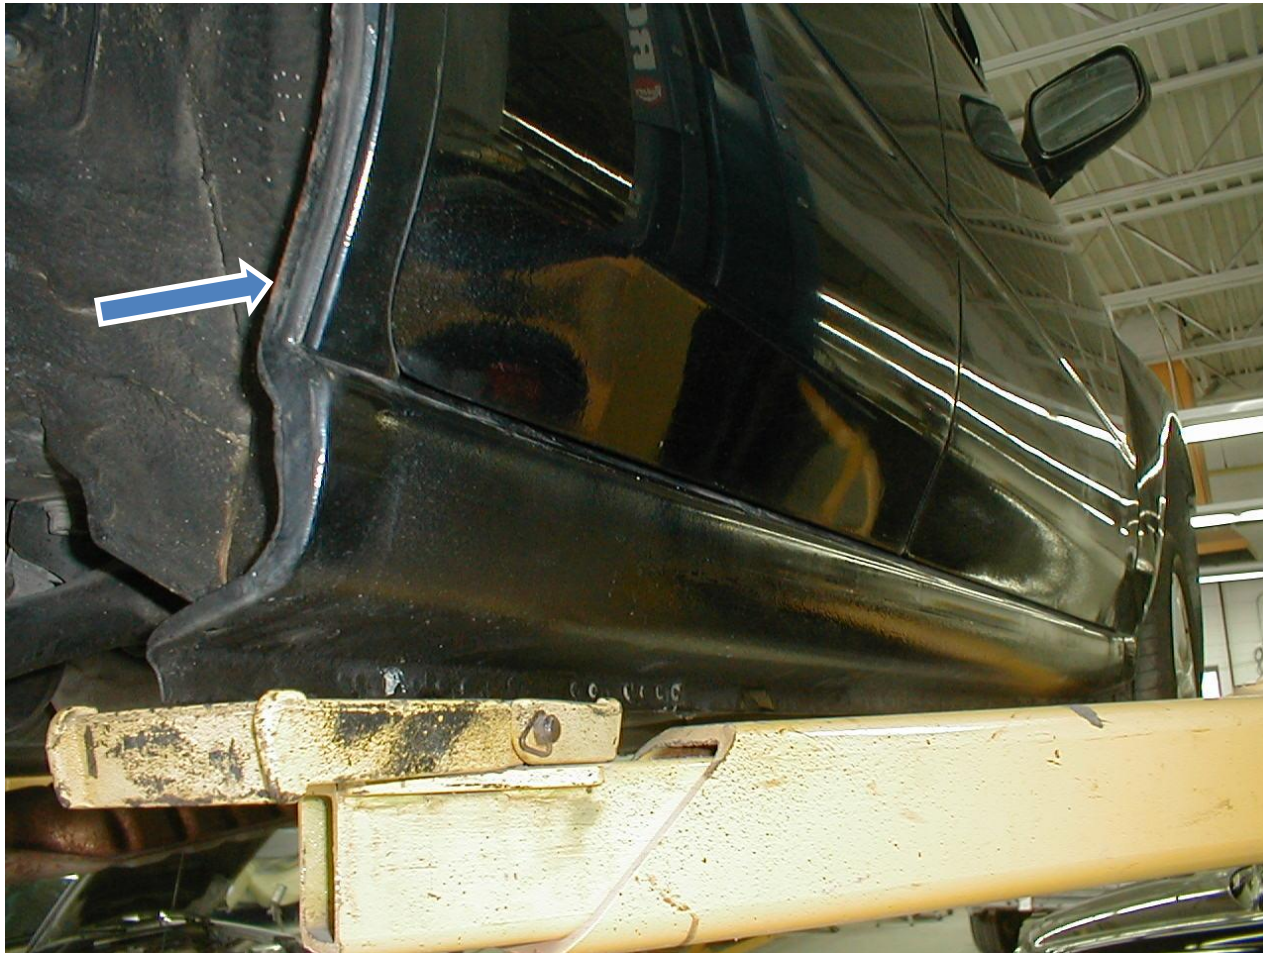
Rusted and poor welds between outer quarter panel and inner wheel house. No seam sealer or corrosion protection.

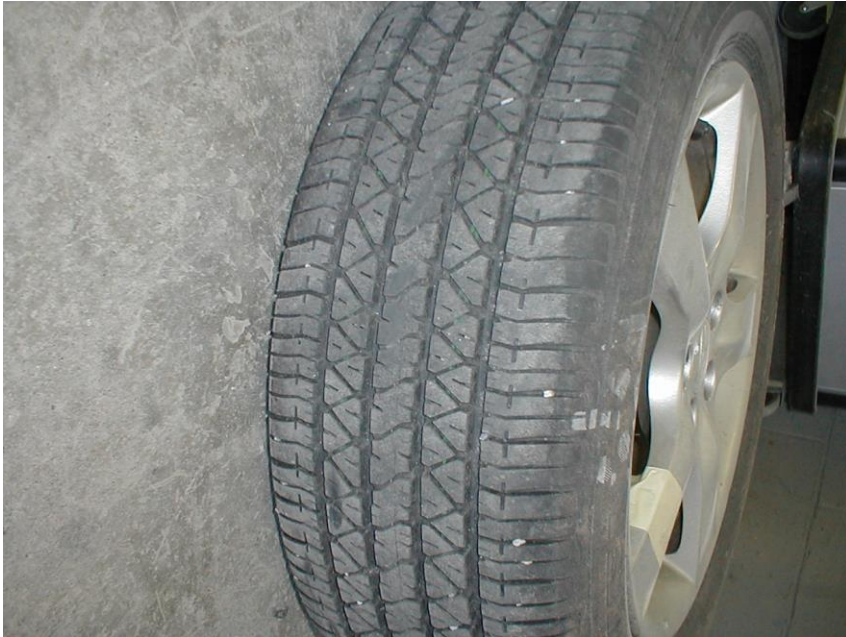
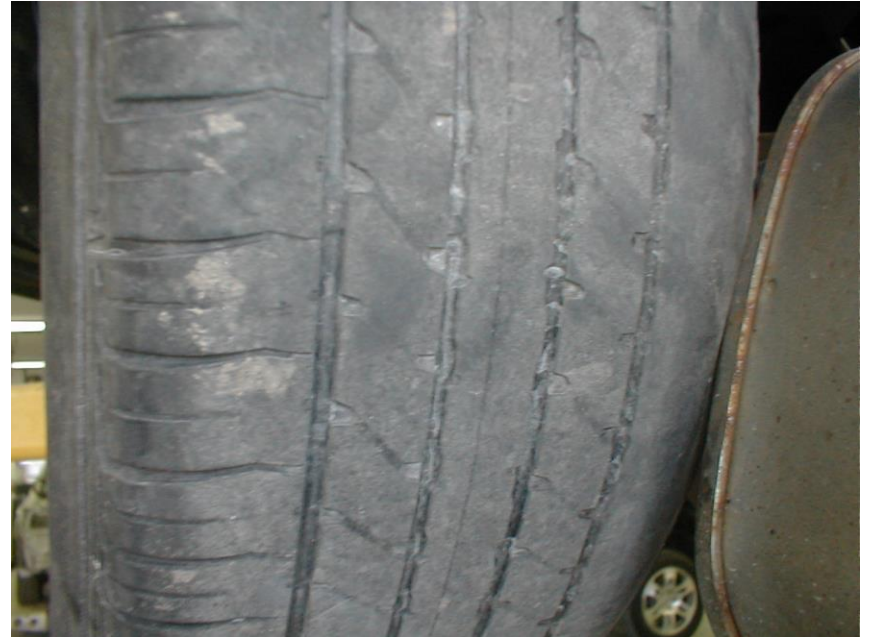
Tire comparison

**Right rear tire in left picture frame
had been replaced recently**

**Three out of the four tires were
worn in a similar fashion as this tire
due to misalignment of frame and
rear suspension carrier**

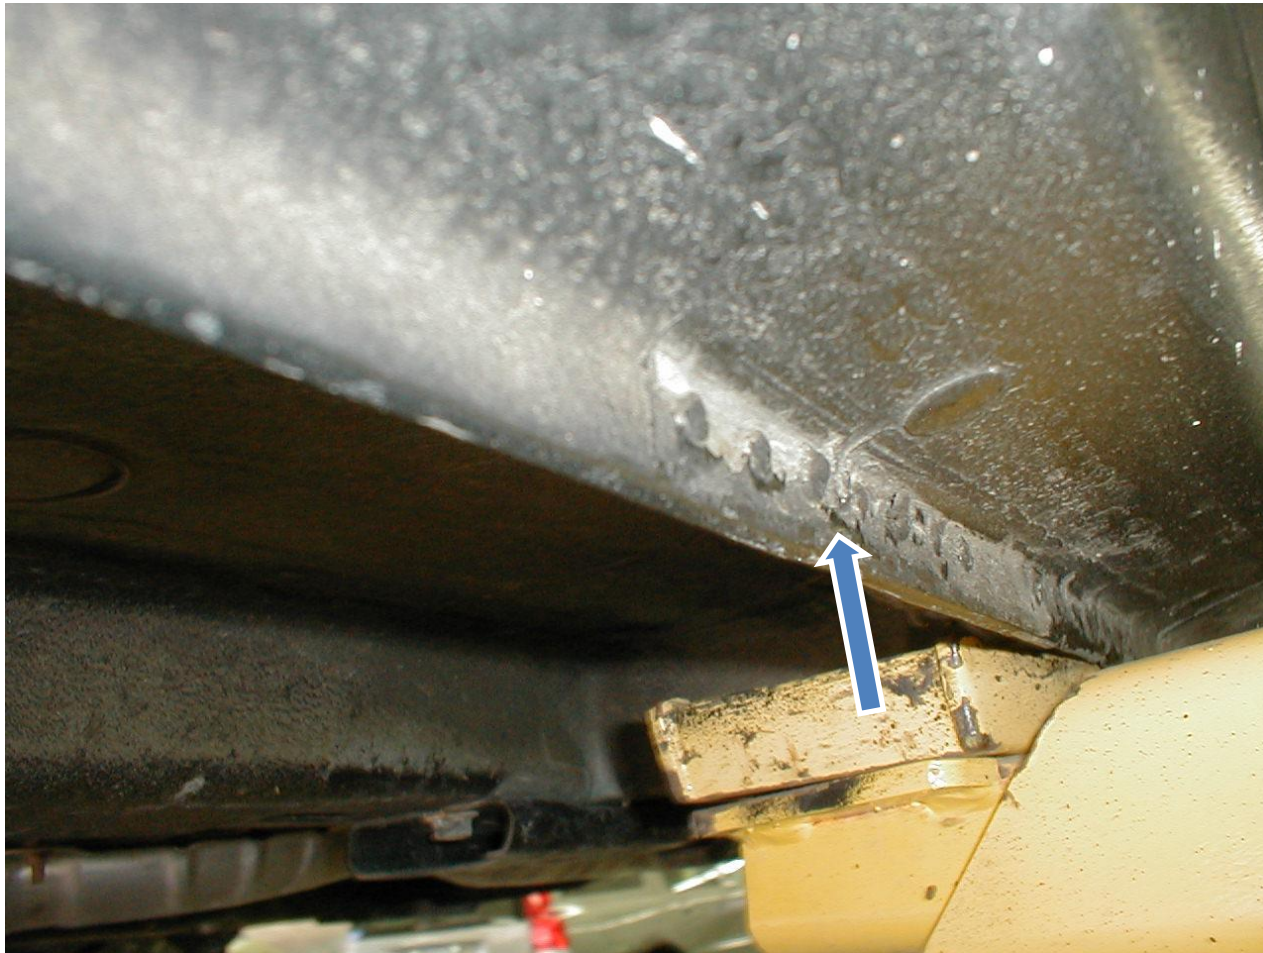
Unrepaired clamp marks made from affixing vehicle to frame machine

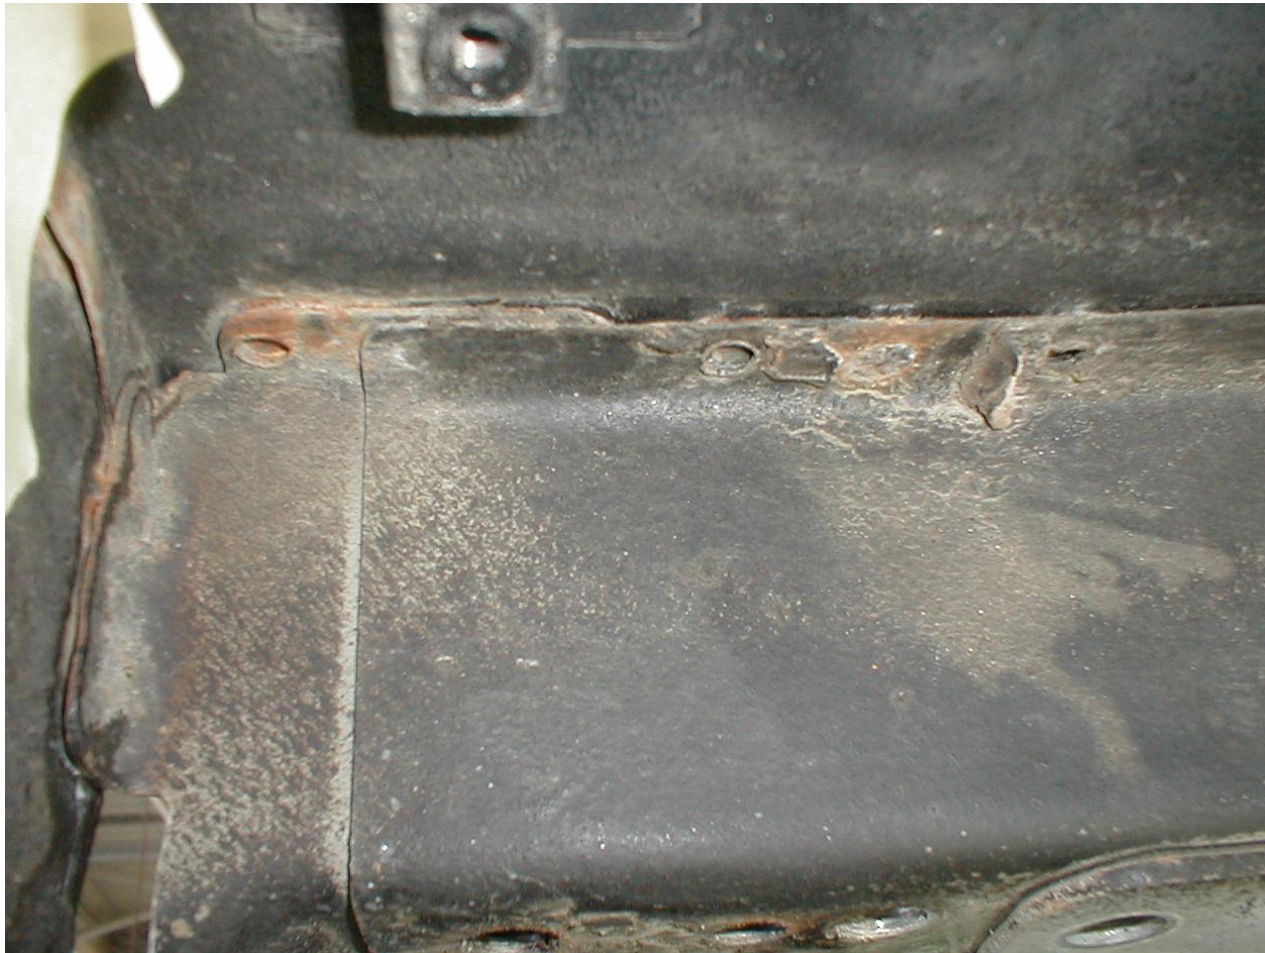
Poor quality and insufficient amount of welds on frame rails, no seam sealer, no paint and no corrosion protection.

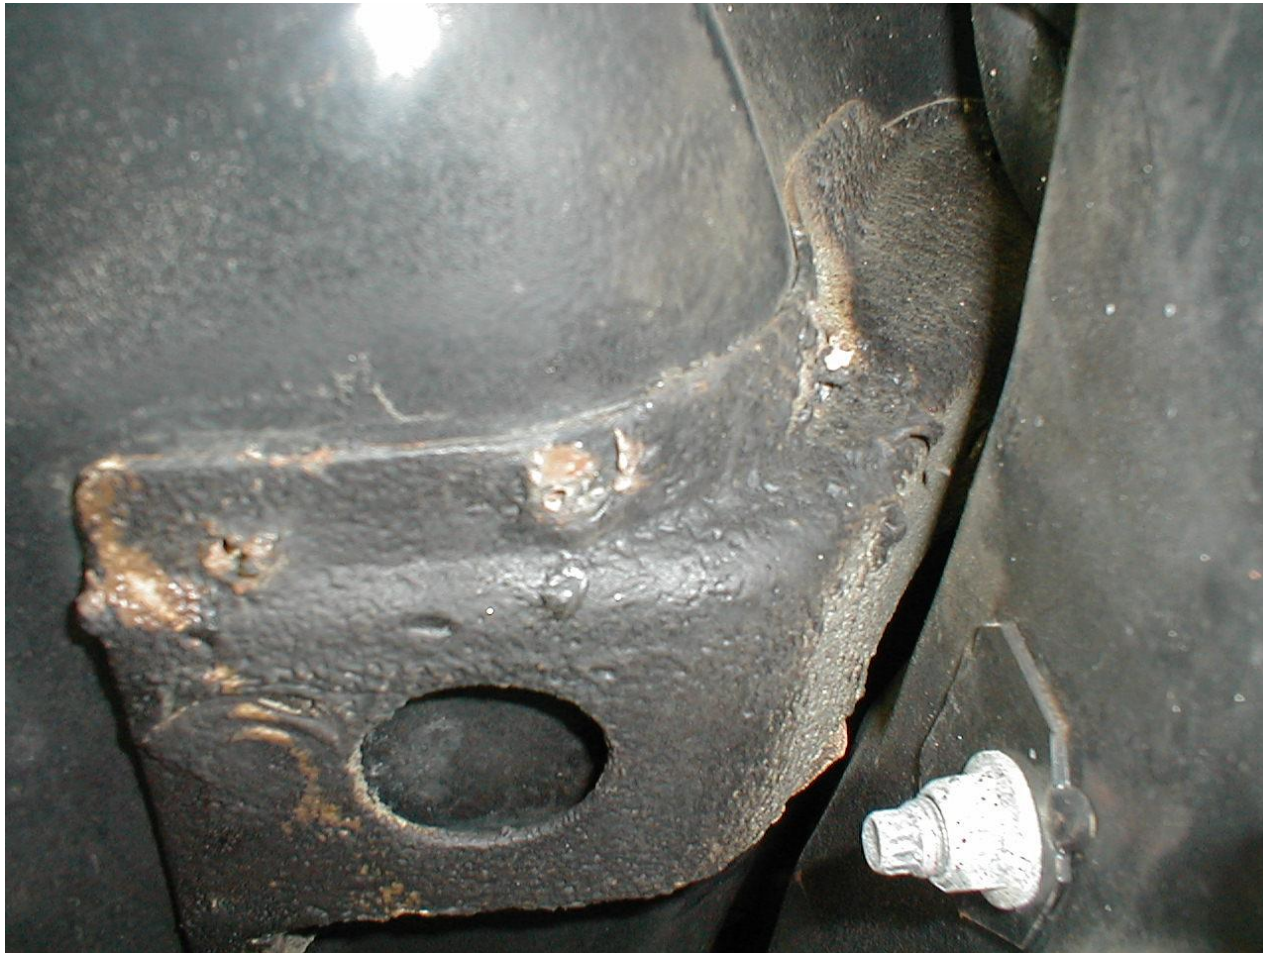
Trunk floor underside reinforcement, poor welds, no seam sealer or corrosion protection

- All of the preceding pictures of the repaired and welded areas of the underside of this vehicle show a rusting condition due to poor welds, no paint and no corrosion protection.
- This vehicle was in service only one year after this repair was completed. Because of the lack of seam sealer and corrosion protection the integrity and strength of the unit-body structure would continue to deteriorate to the point of complete disintegration in a short period of time.
